Manhole Inspection Summary

Manhole # S27C__010MH

Insp Date: **6/19/09 9:44 AM**

Location Address: **906 FRANKLIN ST**

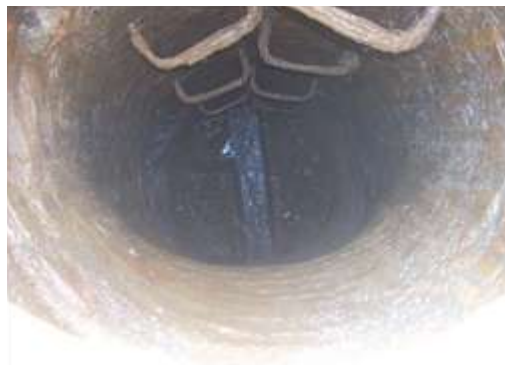
Defect 1

Steps Count: **9** Missing: **0** ☒ **Corroded**

CORRODED STEPS

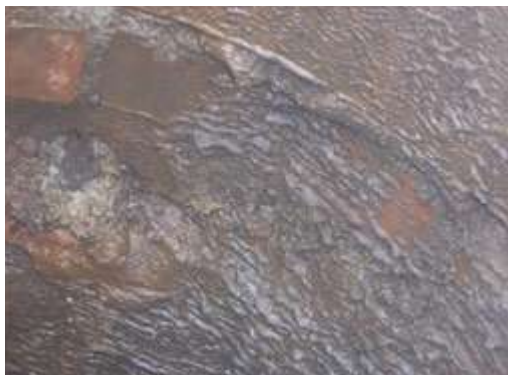
Defect 2

Condition: ☐ Sound ☐ Cracked ☐ Root Intrusion ☐ Loose Brick ☒ **Deteriorated**

CORBEL DETERIORATION

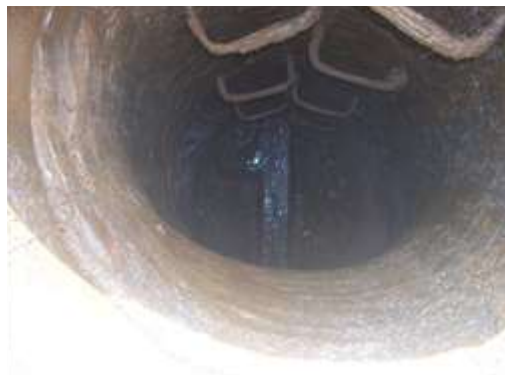
Defect 3

Surcharge ☒ **Evidence Of Surcharge** Depth: **4** (ft.) ☐ Active Surcharge Present

evidence of ASUR

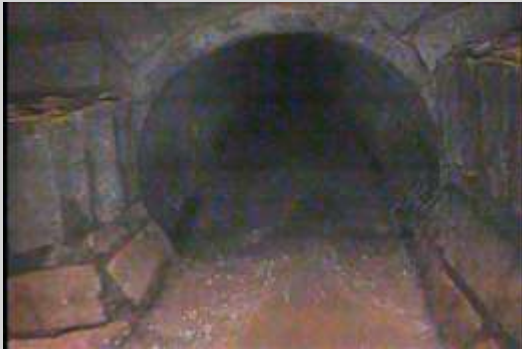
12 O'Clock Outflow

12 in. Circular Gravity Sewer
Pipe Out @ 12 O'Clock

Pipe Height: **12** (in.) Rod and Bar (Angled)
Pipe Material: **Clay** ☐ Pipe Lined
Invert Depth: **13.68** (ft.) Flow Characteristics: **Slow**
Deposits: ☒ None ☐ Mud ☐ Sludge ☐ Debris ☐ Grease
Silt Depth: (in.) Deposits Extent:
Infiltration: **None** Pipe Seal Cond: **Sound**

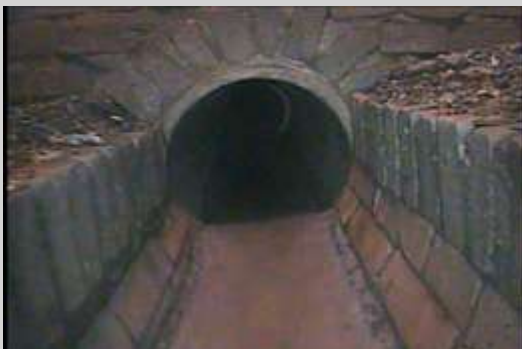
6 O'Clock Inflow

12 in. Circular Gravity Sewer
Pipe In @ 6 O'Clock

Pipe Height: **12** (in.) Rod and Bar (Angled)
Pipe Material: **Clay** ☐ Pipe Lined
Invert Depth: **13.66** (ft.) Flow Characteristics: **Slow**
Deposits: ☒ None ☐ Mud ☐ Sludge ☐ Debris ☐ Grease
Silt Depth: (in.) Deposits Extent:
Infiltration: **None** Pipe Seal Cond: **Sound**
